Manhole Inspection Summary

Manhole # S17II1004MH

Location Address: **2319 DERBY RD** Cross Street: **GREENSPRING AVE**

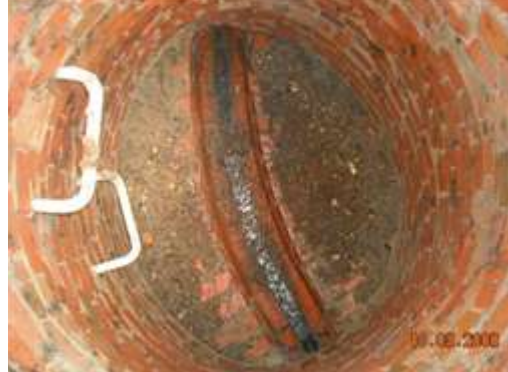
Top View

Bench ☒ Exists Material: **Brick** ☐ Parged ☒ **Debris** (not Condition related)
Condition: ☒ Sound ☐ Cracked ☐ Root Intrusion ☐ Deteriorated ☐ Leaks ☐ Debris

Surcharge ☒ **Evidence Of Surcharge** Depth: **1** (ft.) ☐ Active Surcharge Present

Evidence of surcharge - Bench debris.

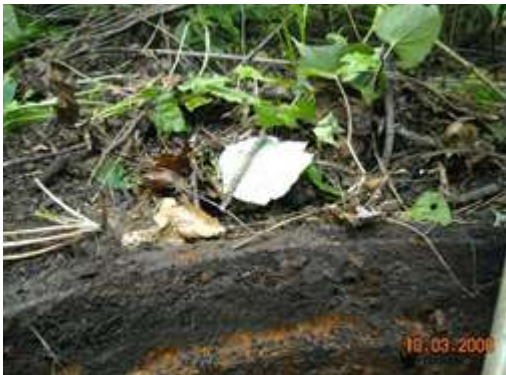
Defect

Below grade.

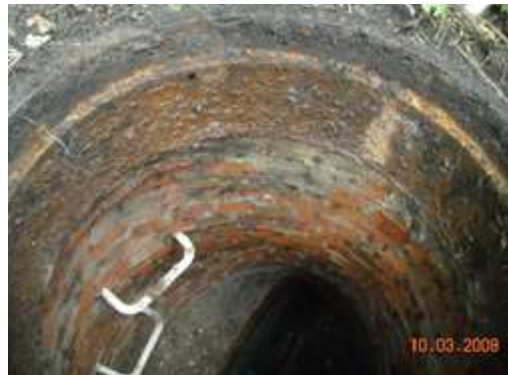
Defect

Corbel Material: **Brick** ☐ Parged Type: **Concentric/Eccentric**
Condition: ☒ Sound ☐ Cracked ☐ Root Intrusion ☐ Loose Brick ☐ Deteriorated
Infiltration: ☐ None ☒ **Joint** ☐ Cracks ☒ **Mortar** ☐ Roots ☐ Wall

Barrel Material: **Brick** ☐ Parged
Shape: **Circular** Diameter: **42** (in.) Length: (in.)
Condition: ☒ Sound ☐ Cracked ☐ Root Intrusion ☐ Loose Brick ☐ Deteriorated
Infiltration: ☐ None ☐ Joint ☐ Cracks ☒ **Mortar** ☐ Roots ☒ **Wall**

Frame leaks. Corbel and Barrel infiltration.
